## Eliminating squeal from the fan end of an EM20/B vacuum pump

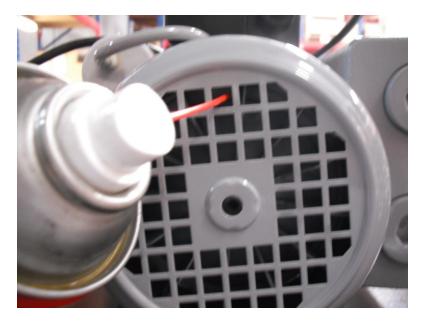
If thorough dust removal does not remove the squeal, it's possible the cause of the squeal is a dry seal where the shaft passes through the fan end bearing housing to support the fan. It is worth trying to lubricate the seal with the fan cover still in place. Before doing this, STOP THE PUMP! Apply a spray lubricant through the top centre hole in the grill. Locate the discharge of the spray tube above the solid centre of the fan so that the lubricant hits the fan end bearing housing and dribbles down onto the shaft. After spraying the lubricant, leave the pump stopped for a few minutes to allow excess to dribble out the bottom of the fan cover. After a few minutes, blow compressed air through the fan grill to remove as much excess lubricant as possible.

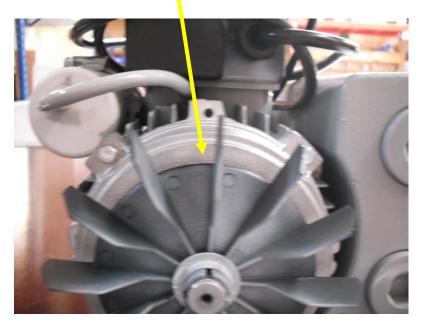
The aim is to get the lubricant to hit here:

Note that the fan cover has been removed for the last 2 photos, but this should not be necessary.
